# Horning Geosciences

July 13, 2016

RE: Geological Inspection; Nehalem Valley Care Center; Tax Lot 300, Map 2N 10 3DD; Wheeler, Tillamook County, Oregon

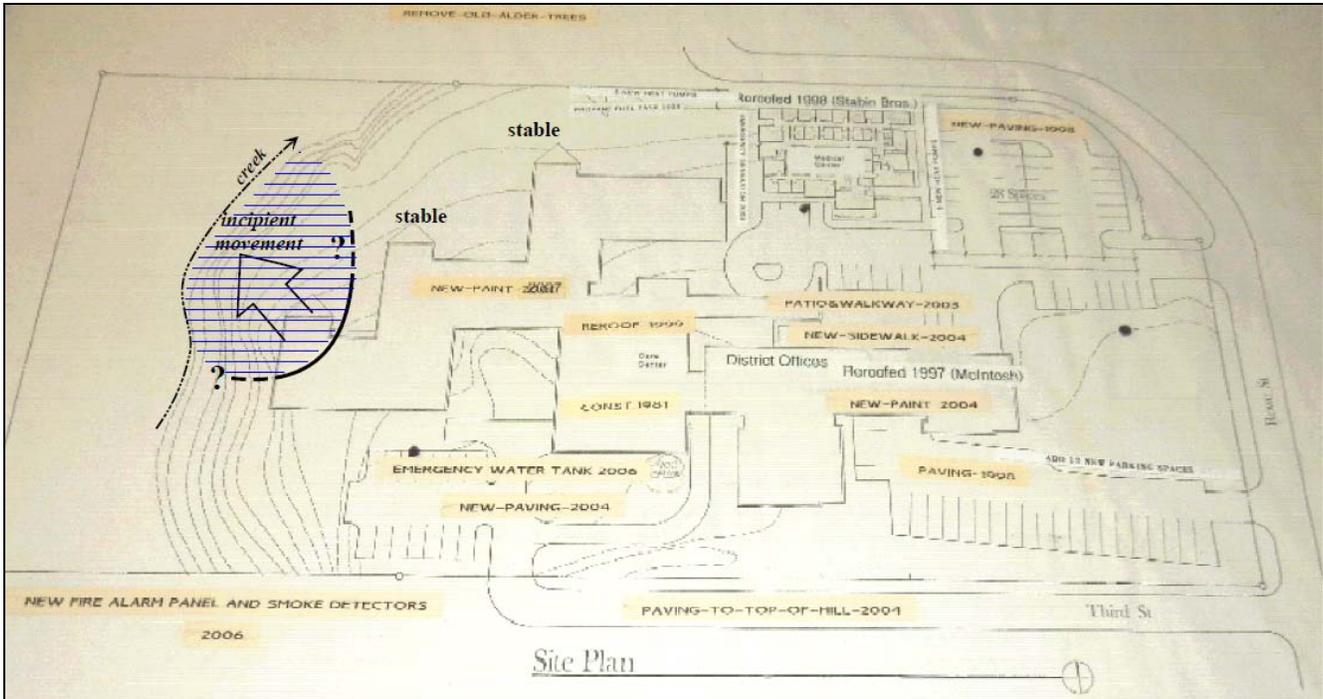
The southwest wing of the NVCC facility has been deformed by ground movement. The boundary of the slide damage is illustrated in Figure 1. Lateral extension is greater than vertical displacement, the direction of movement to the west. The edge of the building is near the edge of steep slopes that drop down into the creek gully. It has been built too close to the steep slopes and should have been set back an appropriate distance to avoid the movement. In the building, floors have been cracked, lino-

leum tiles breaking away to reveal cracks up to 2/3 inches across. Window glass in the salon is becoming loose in its frame. Sheet rock in the hallway has rifted open. Examination outside finds that soils have dropped from beneath the concrete footings as the land has dropped.

The southwest wing of the NVCC facility has been slowly deforming from incipient landslide movements for many years. The rate of movement is observed to have increased in the winter of 2015-16. This coincides with exceptional rainfall and landslide events during the period that includes December 9, 2015, when the three-day rainfall totals ranged from 9 to 13 inches, causing unparalleled debris flows and flooding. In the past, cumulative rainfall amounts in excess of 6 inches in 3 days have triggered significant slides. It is therefore concluded that the heavy rains increased the rate of slide damage to the southwest wing of the NVCC facility. Assuming that this coming winter is average in storminess, the rate of slide movement will be less than last winter and it will be incremental in nature. If the coming La Nina winter is more like record-setting rainfall of 1998-99, the rate of deformation will be higher, more like that of the winter of 2015-16. It is unlikely that landslide movement will be catastrophic or rapid in either case. Should the rate of slide movement increase due to high rainfall, the movement will be gradual, and perhaps noticeable over a period of a day or so, allowing the wing to be closed temporarily until rates drop once again. Utilities that cross the boundary of slide movement may be stretched and damaged. It is unlikely that movement will be more than one inch of lateral movement in one week to one month.

Figure 1: Sketch of original topography and building plan with area of known movement shown by hatching.

Open the wing and use it as you have in the past, until movement increases enough to warrant temporarily closing it down. Make sure that drains collect rainwater and pipe it to the base of slope where it can join creek water. Be prepared to shut down any water lines that cross the boundary of the slide, so as to limit accidental saturation.
